River Cheptui bridge caves in

Cheptui bridge, located along Muyembe-Nakapiripirit highway, has caved in.

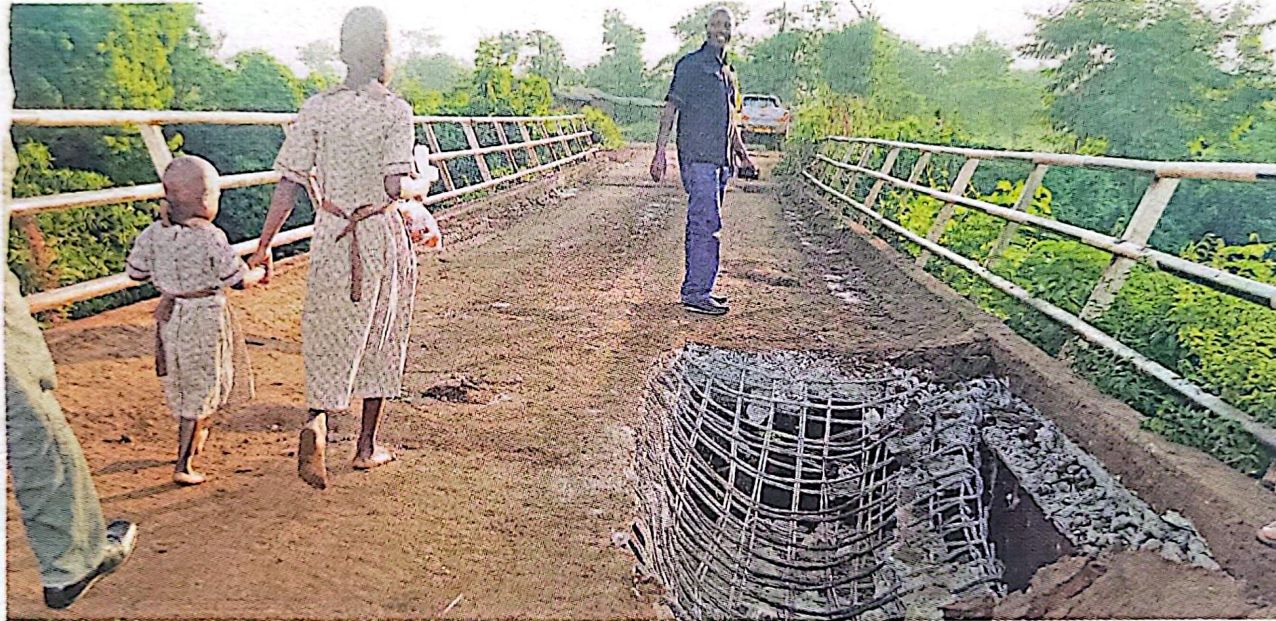
River Chetui, from where the bridge derives its name, serves as a natural boundary between Bwikhonge and Bunambutye sub-counties in Bulambuli district. The concrete surface of the bridge has gorged out, eating away about half of the road.

"We woke up to find the bridge had collapsed. But we suspect it could have collapsed under the weight of one of the cement trucks which use the route to pick marble from Amudat district," Joshua Masike, a resident explained.

Children walk past the damaged Cheptui bridge along Muyembe-Nakapiripirit highway. Photo by Daniel Edyegu

"That temporary bridge was projected to last three years. It is built to hold not more than 15 tonnes. But cement trucks load up 30 tonnes of marble. This has weakened the bridge. We are in the process of putting another overlay (concrete crossover bridge) at that spot. It will be ready in about three weeks," Ssonko explained.

To avoid accidents on the bridge, Uganda National Roads Authority (UNRA) has temporarily blocked the route and diverted motorists to the 270km Mbale-Soroti-Moroto
